PERFORMING ORGANIZATION NAME AND ADDRESS
TRW Defense and Space Systems Group / One Space Park Redondo Beach, CA 90278

>Presents the results of an investigation of the cause of failure of a 20 watt amplifier considering orbital data and laboratory simulation. Ascribes the failure to the power supply (not the tube) and suggests a probable cause.

# SATELLITE 9441 20 WATT TWTA ANOMALY REPORT

Report No. 36060-AR-021-01 CDRL No. 009A2 F04701-80-C-0022 15 April 1980

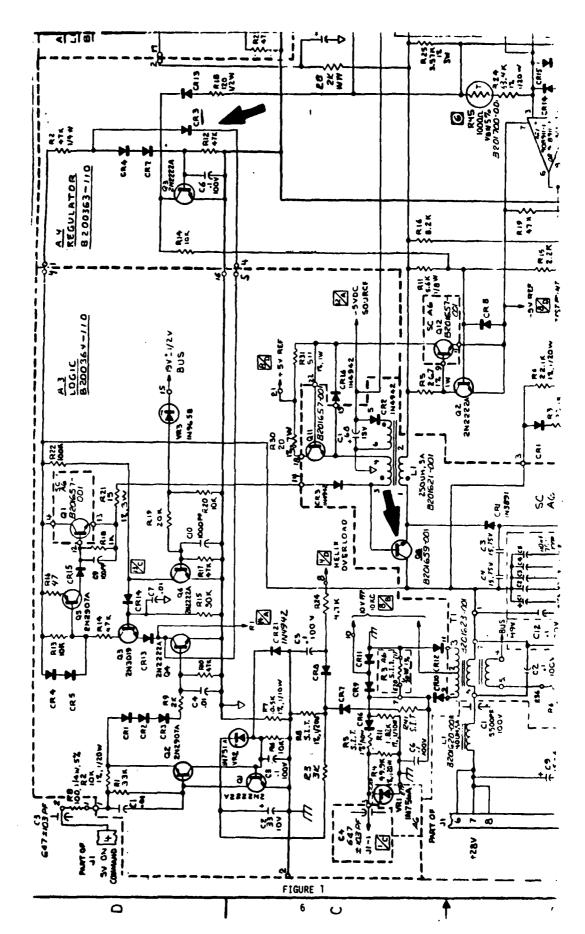
Referring to schematic B200350-210 Sheet 2, a portion of which is shown in Figure 1, it will be noted that the 19 volt bus voltage regulator is controlled by the impedance of A4-CR3 (zone D12). CR3 is a IN4148. If it should fail to a high impedance (approximately  $1.5 \mathrm{k}\Omega$ ), the 19 volt bus is controlled to a low voltage. The switching regulator transistor, Q8 (2N3599) (zone C14), then runs in a linear mode at high power and thus fails. Hughes part specialists advise that the likely failure is to a fixed relatively high impedance (approximately  $9\Omega$ ). The 19 volt bus is then permanently at a low (random) voltage and the observed symptoms are observed.

The symptoms were duplicated by Hughes by setting up the above sequence of events in the breadboard power supply. Table I-IV A, B and C show the resulting amplifier behavior.
